TECHNICAL REPORTS SERIES NO. 439

Decommissioning of Underground Structures, Systems and Components

INTERNATIONAL ATOMIC ENERGY AGENCY
VIENNA, 2006

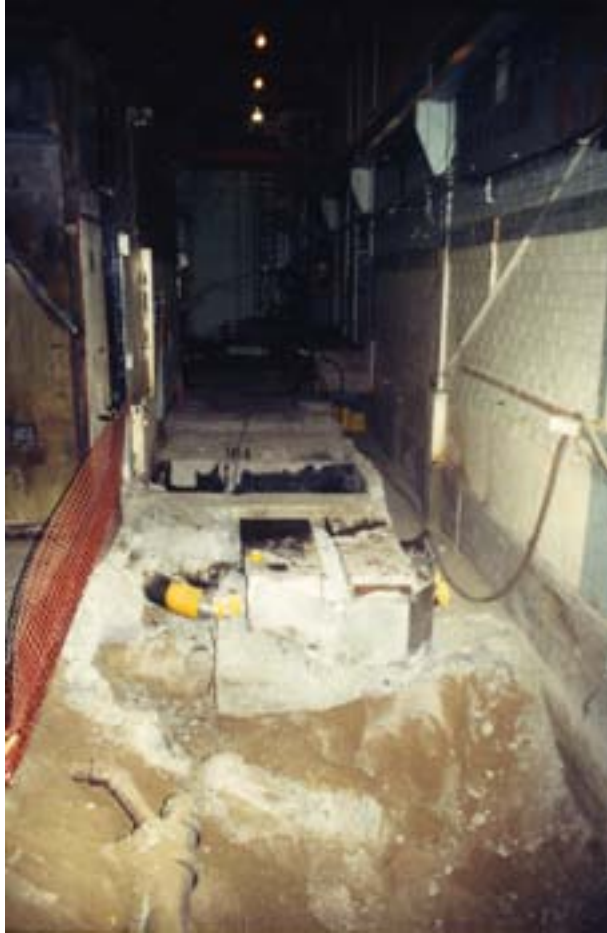
FIG. 4. Hot cell dismantling: removal of various embedded process systems for servicing the cell at the radioisotope production facility at Tunney's Pasture, Ottawa, Canada. Courtesy: Atomic Energy of Canada Limited.

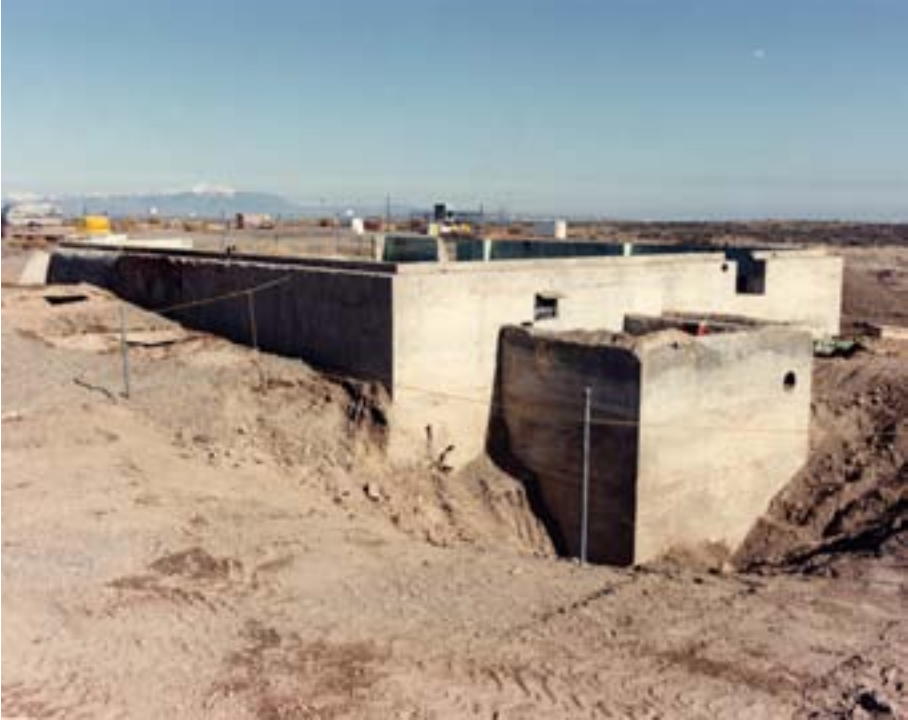
FIG. 5. Removal of contaminated soil around the boiling water reactor (BORAX) turbine building at Idaho National Engineering Laboratory, Illinois, USA.

- (f) Possible contamination of nearby components and/or structures and the soil due to leaking pipes, and uncertainties about the extent of peripheral remedial work which may be required (Fig. 5).

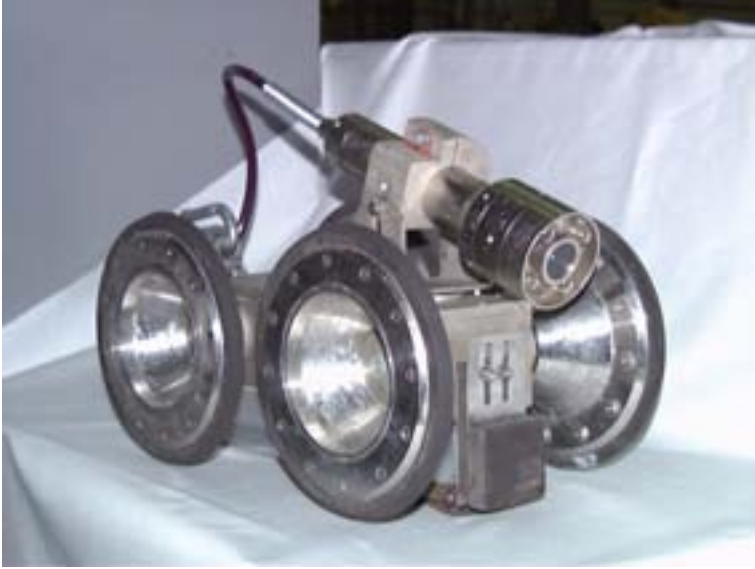
FIG. 6. A pipe characterization trolley of type PVK-3, used in the Czech Republic.

For the purpose of inspection of underground structures, special devices may need to be utilized. Several applications for pipe inspection in the Czech Republic using closed circuit television cameras mounted on trolleys are described in Ref. [80] and are depicted in Figs 6 and 7.

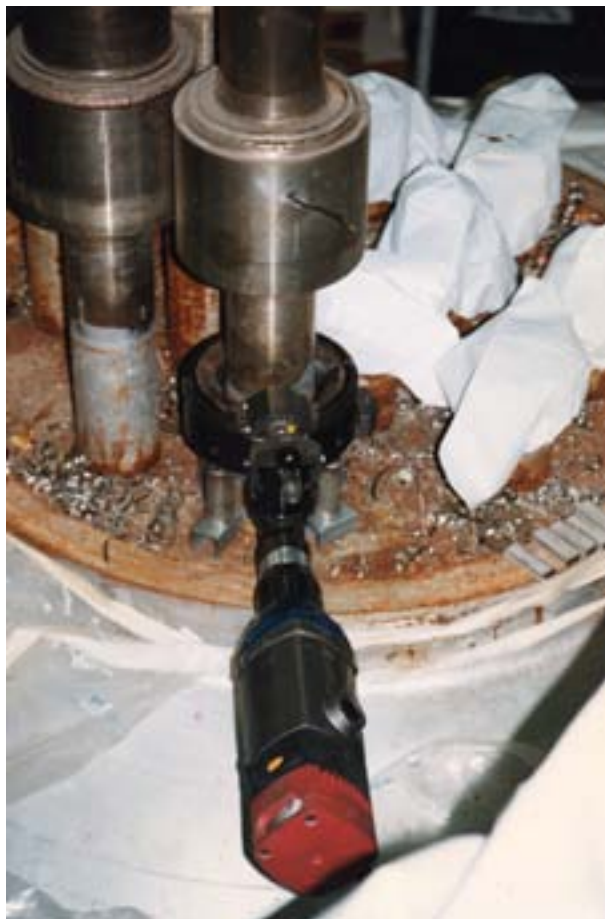
FIG. 10. Cutting reactor head standpipes using an orbital cutter with a lathe at the BR-3 Mol decommissioning project, Belgium. Courtesy: Studiecentrum voor Kernenergie – Centre d'Étude de l'Énergie Nucléaire (SCK·CEN).

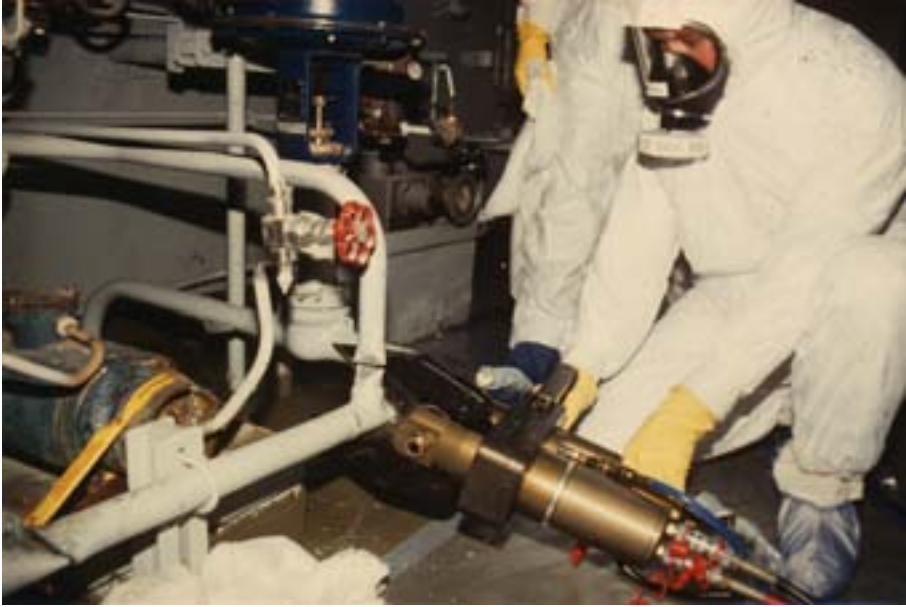
FIG. 11. Cutting pipes with diameters of up to 2 in (5 cm) using hydraulic shears at the Mol decommissioning project, Belgium. Courtesy: SCK·CEN.

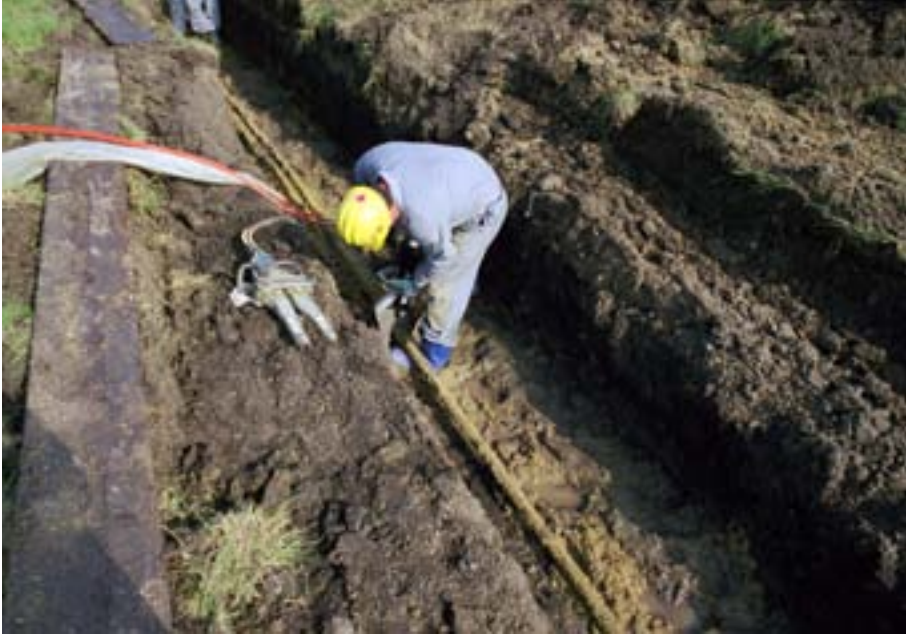
FIG. 12. Dismantling of a buried pipe using hydraulic cutters at the ANL pneumatic transfer tube project, Argonne, Illinois, USA. Courtesy: Argonne National Laboratory, managed and operated by the University of Chicago for the USDOE under Contract No. W-31-109-ENG-38.

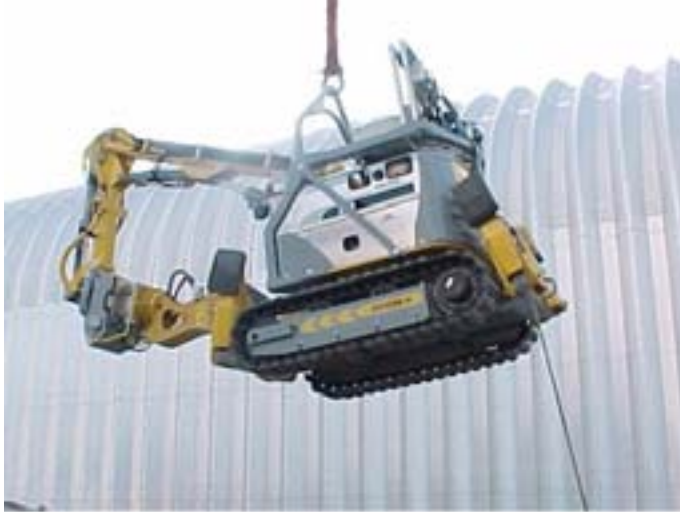
FIG. 14. Lowering of the remotely operated dismantling device (BROKK) into the BGRR duct, Brookhaven, New York, USA.

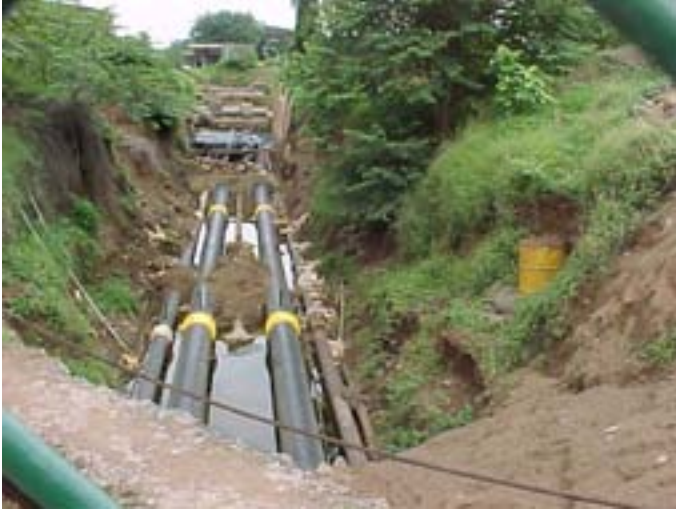
FIG. 15. View of subsoil primary coolant pipes with cold self-adhesive bituminous tapes newly applied before backfilling at the Cirus reactor, India.

All subsurface pipes were then exposed by excavation (Fig. 15). Various methods, such as visual inspection, pressure testing, ultrasonic testing and testing of the protective coating, were used for assessment of their condition. An estimated 8000 m³ of soil was removed and an about 1600 m length of

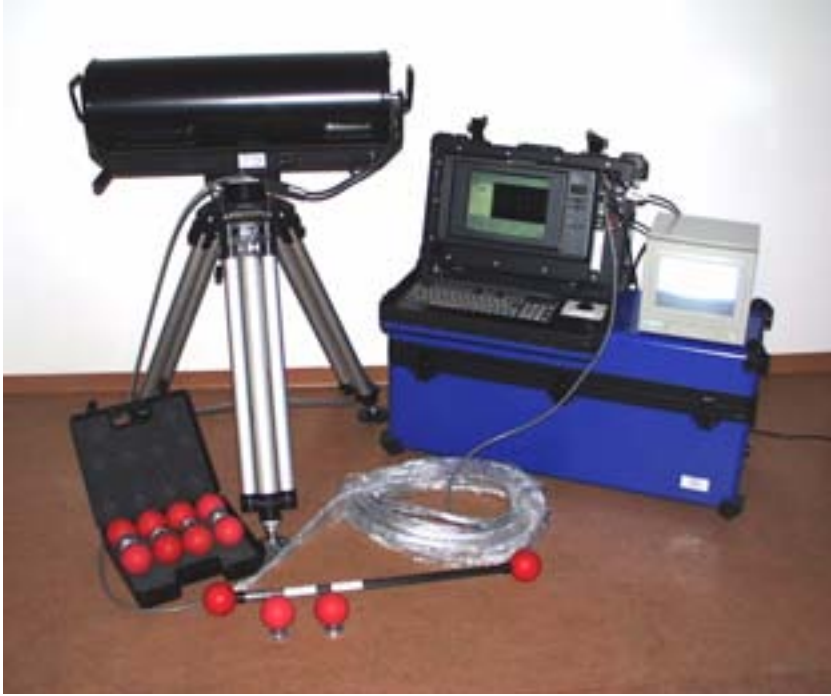
FIG. 16. A 3-D laser scanner in use at the A-1 nuclear power plant decommissioning project, Slovakia.

At the A-1 nuclear power plant decommissioning project in Slovakia, the set of as-built facility drawings is not complete and in other cases has been found not to be 100% accurate. Owing to high radiation levels in the working areas, manual radiological characterization of these work areas is difficult and time consuming. Advanced technologies are being used to perform 3-D modelling of the A-1 nuclear power plant facility before planning the details for implementing the decontamination activities. A combination of 3-D laser scanning and the software 3Dipsos is being used for acquiring hard data on the arrangement of construction and equipment in these areas. Two laser-scanning range sensors are being used at the A-1 project. Soisic from Mensi of France (Fig. 16) operates on the triangulation principle at a rate of 100 discrete points

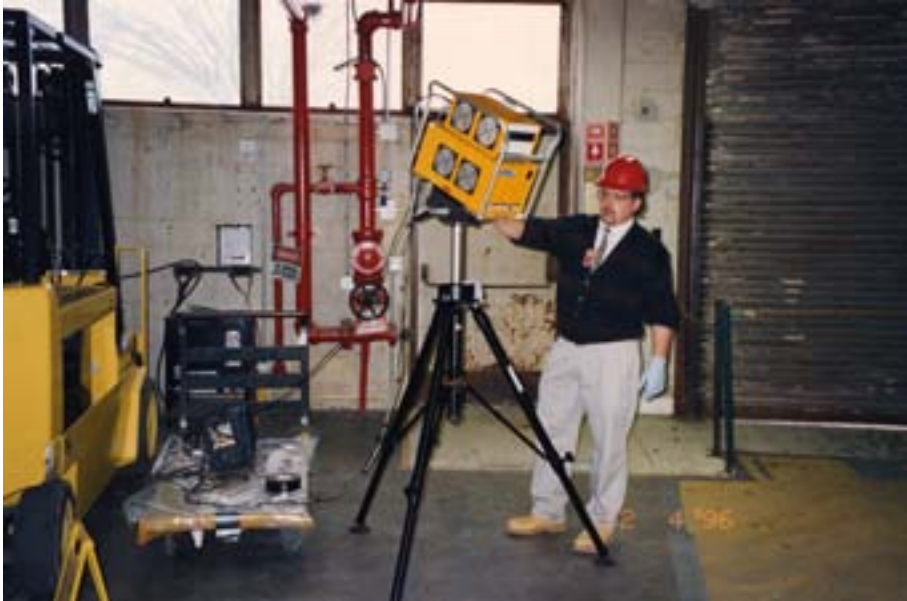
FIG. 17. A GammaCam as used for the gamma radiation field at the CP-5 reactor facility, Argonne, Illinois. Courtesy: Argonne National Laboratory, managed and operated by the University of Chicago for the USDOE under Contract No. W-31-109-ENG-38.

The GammaCam, a gamma ray sensitive camera, superimposes radioactive hot spot data on video images of a facility. This device performed

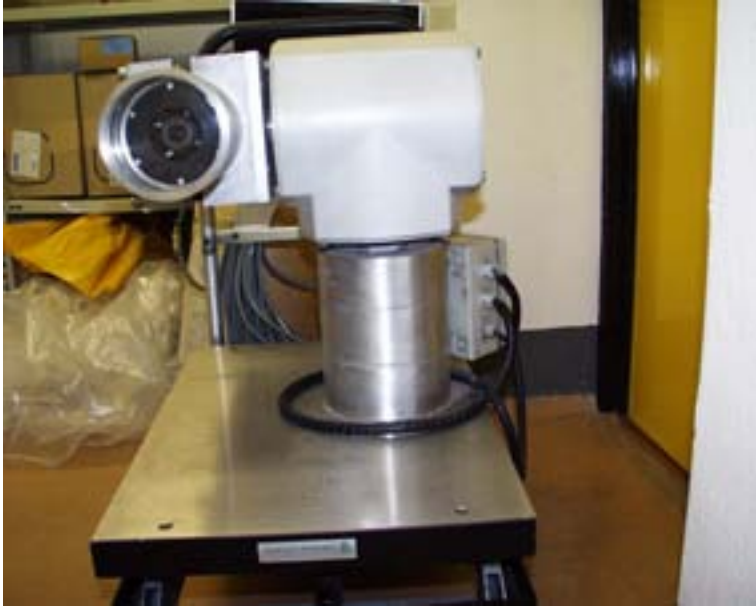
FIG. 18. The ALADIN camera in use at the A-1 nuclear power plant decommissioning project, Slovakia.

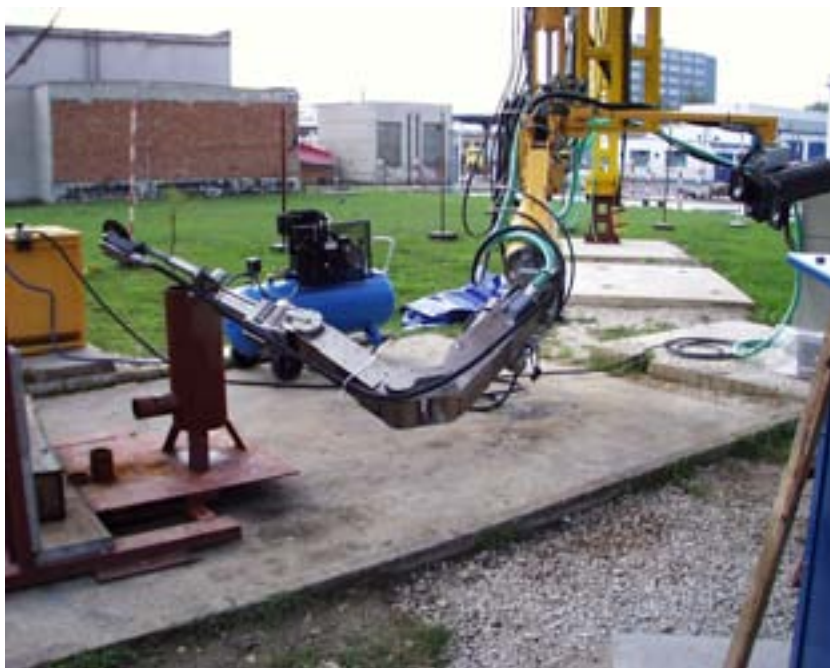
FIG. 19. The DENAR-41 manipulator during mock-up testing, Slovakia.

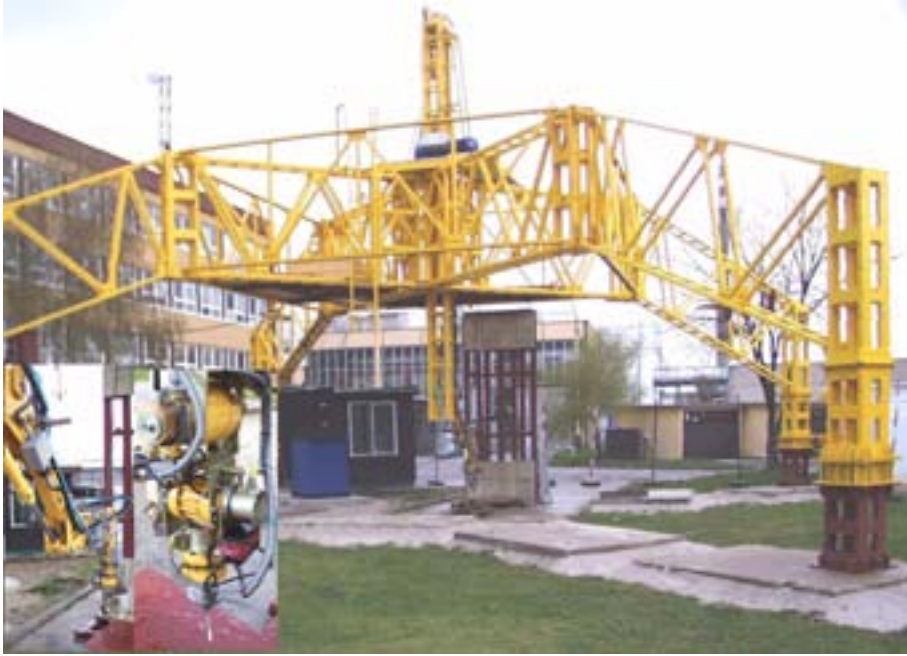
FIG. 20. Full assembly of the DENAR manipulator during mock-up testing, Slovakia.

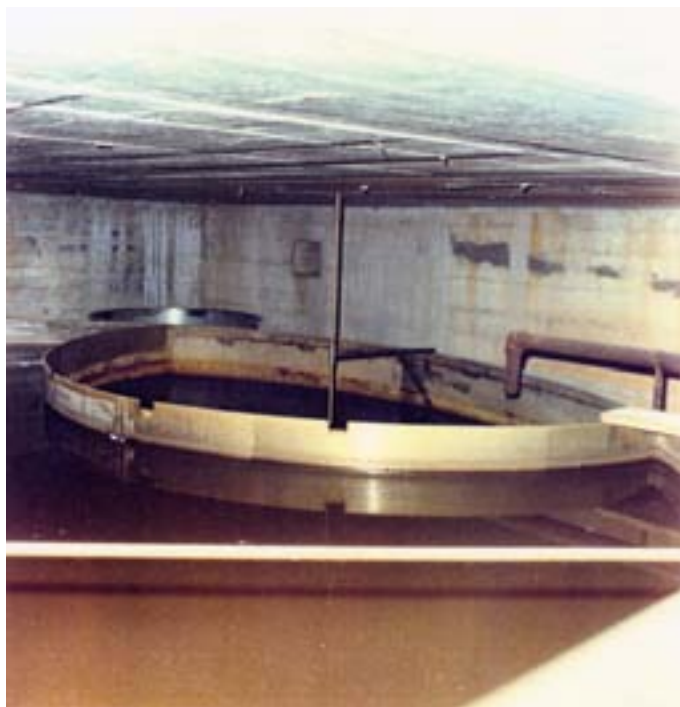
FIG. 22. An underground tank for storing resins at the Garigliano nuclear power plant, Italy. Courtesy: AnsaldoEnergia.

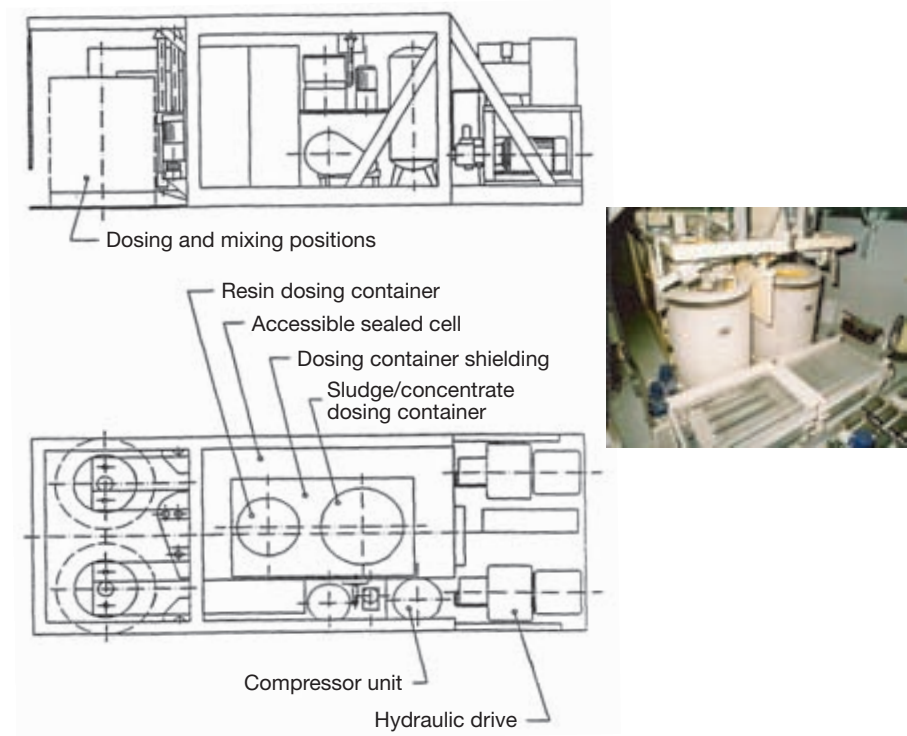
FIG. 23. View of the waste conditioning unit MOWA at the Garigliano nuclear power plant, Italy. Courtesy: AnsaldoEnergia.

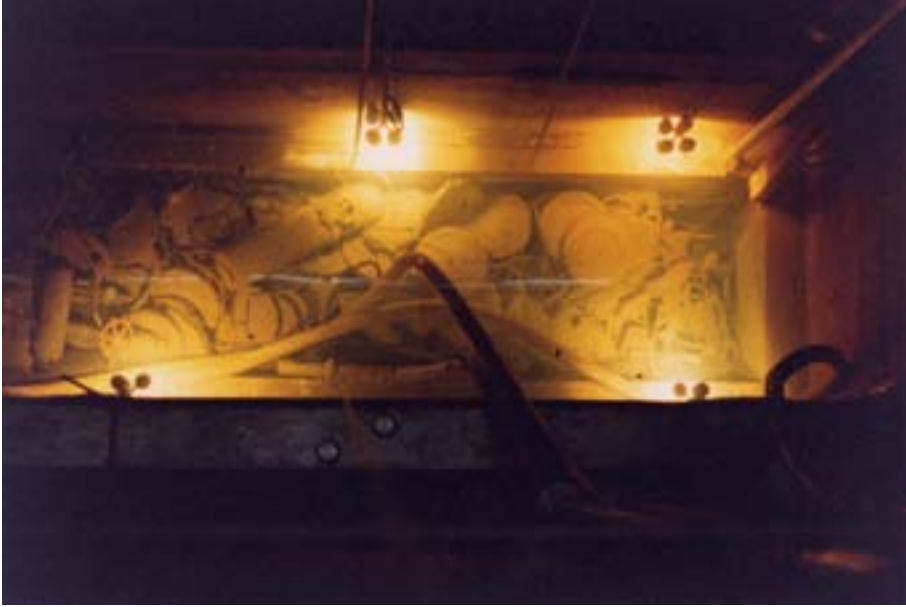
FIG. 24. Wastes piled up in the high activity pit at the Garigliano nuclear power plant, Italy.

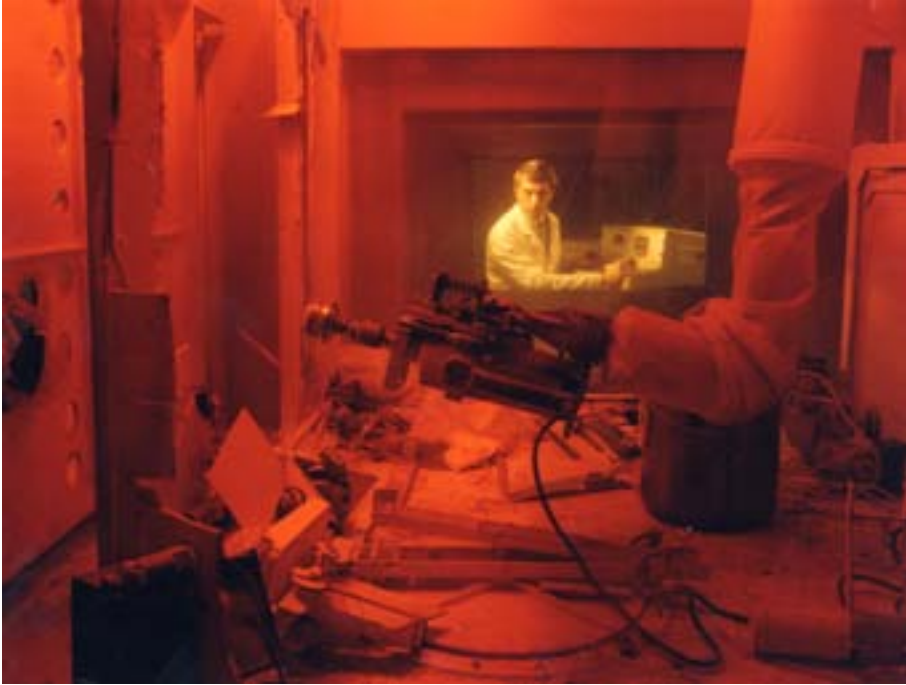
FIG. 25. An ARTISAN manipulator at work during hot cell decommissioning in Building 540, UK. Courtesy: AEA Technology.

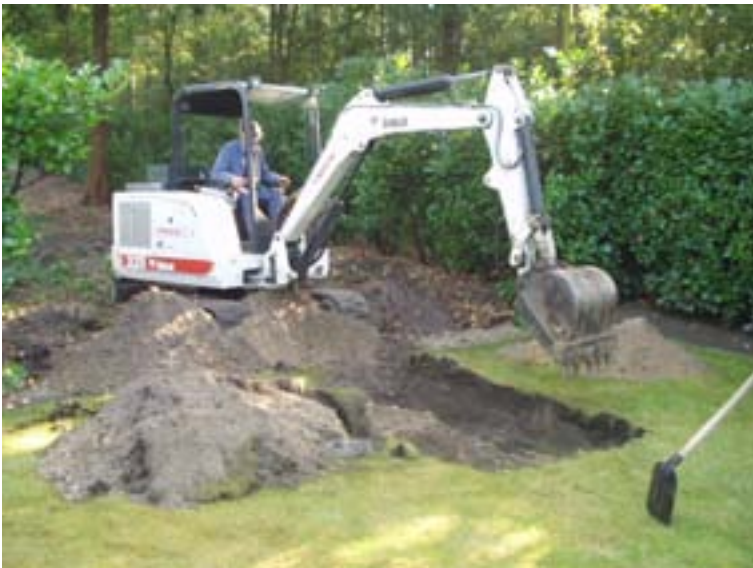
FIG. I-3. Underground pipeline decommissioning in Belgium: removal of soil above the discharge line. Courtesy: Belgoprocess.

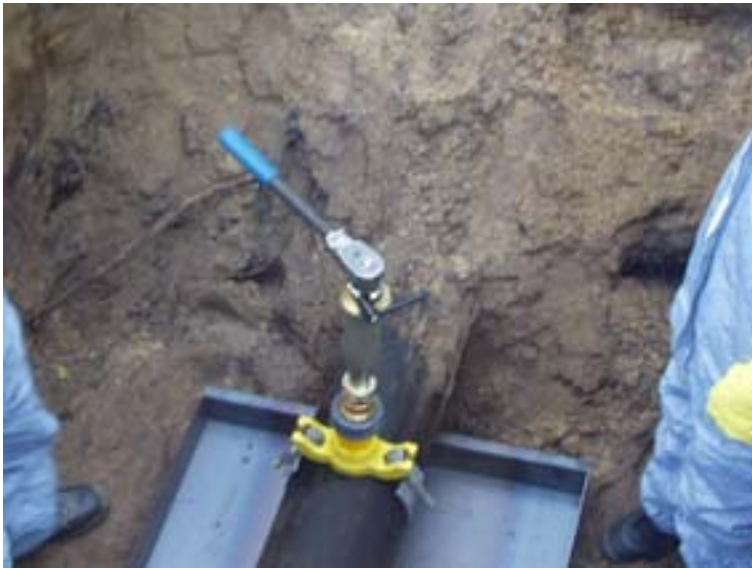
FIG. I-4. Underground pipeline decommissioning in Belgium: boring holes in the discharge line. Courtesy: Belgoprocess.

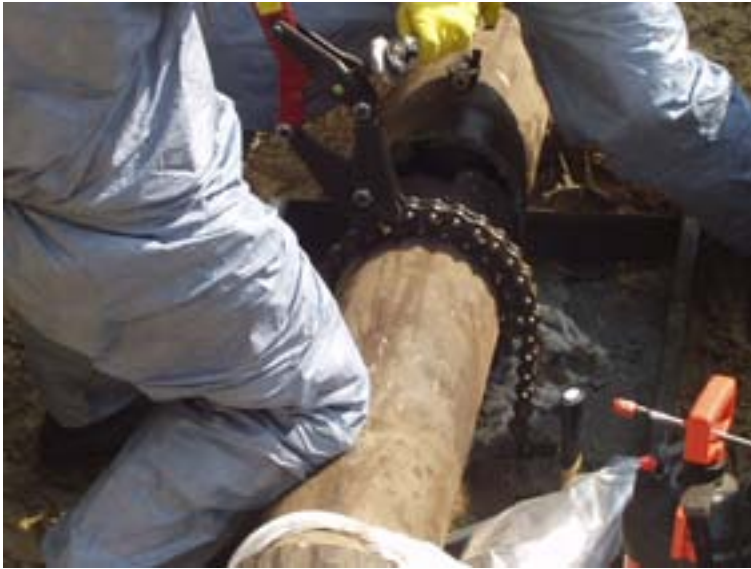
FIG. I-5. Underground pipeline decommissioning in Belgium: the pipe cutter used for cutting asbestos cement pipelines. Courtesy: Belgoprocess.

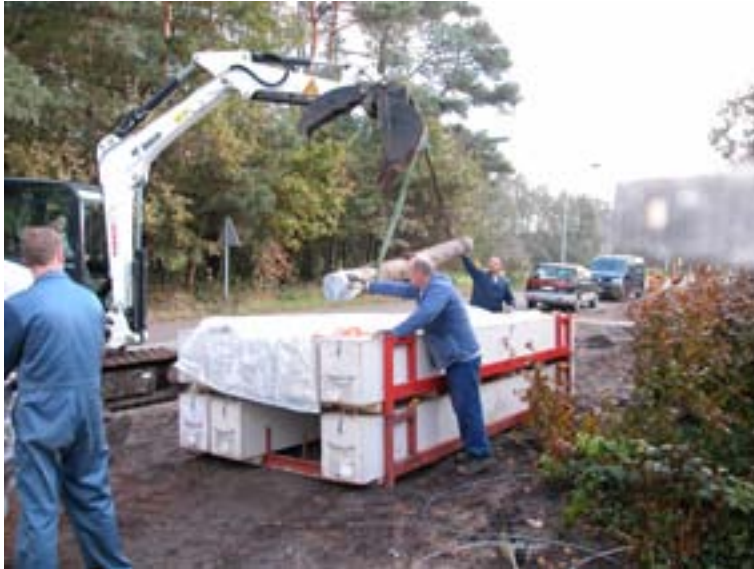
FIG. I-6. Underground pipeline decommissioning in Belgium: sealing of the pipe ducts. Courtesy: Belgoprocess.

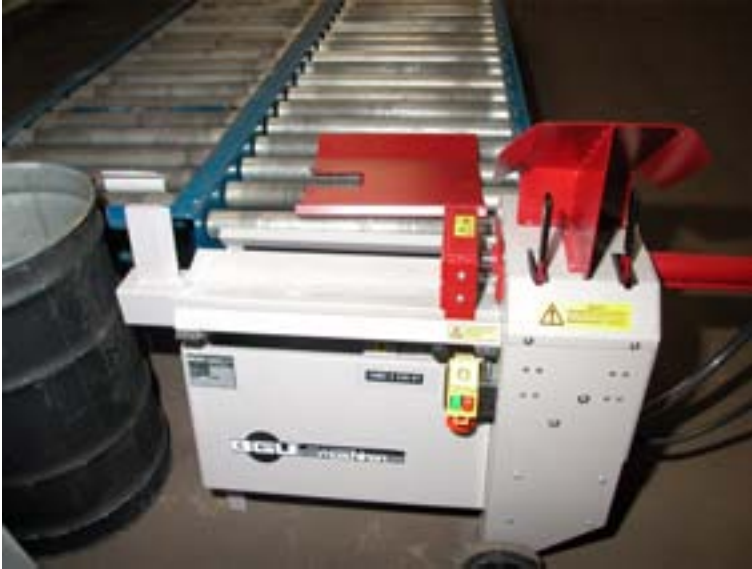
FIG. I-7. Underground pipeline decommissioning in Belgium: size reduction of the pipe ducts. Courtesy: Belgoprocess.

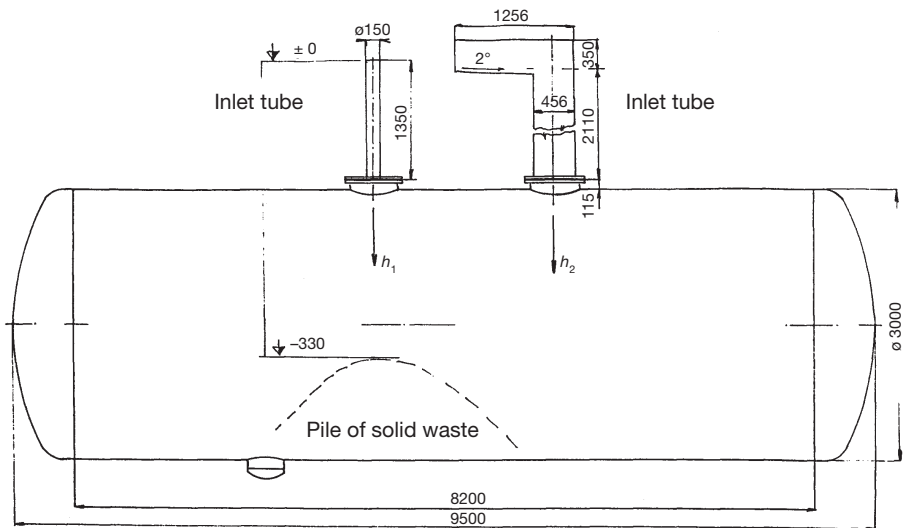
FIG. II-2. Section of a decay tank in building 211/5 (dimensions in millimetres).

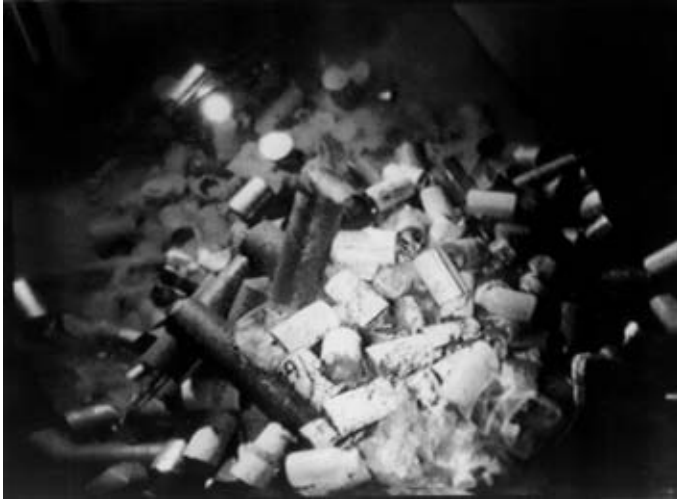
FIG. II-3. Radioactive waste stored in decay tank B in building 211/5.

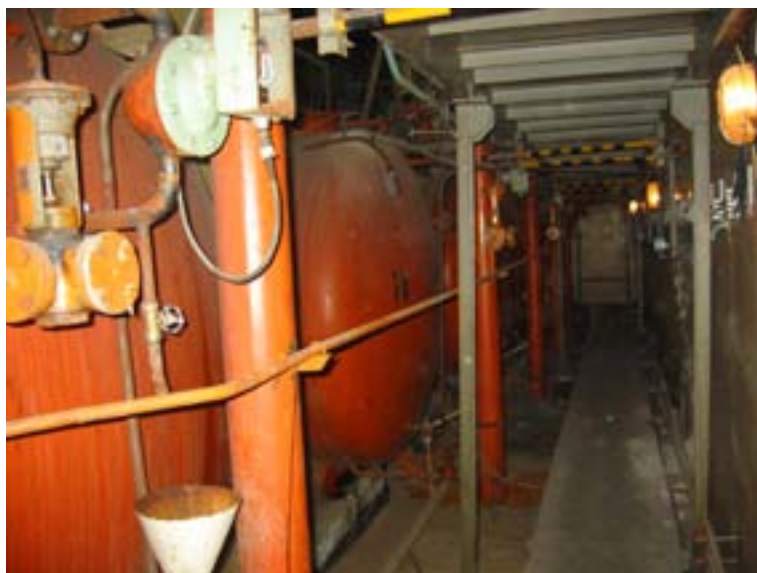
FIG. II-5. The underground bunker with a storage tank in building 241 at NRI in the Czech Republic.

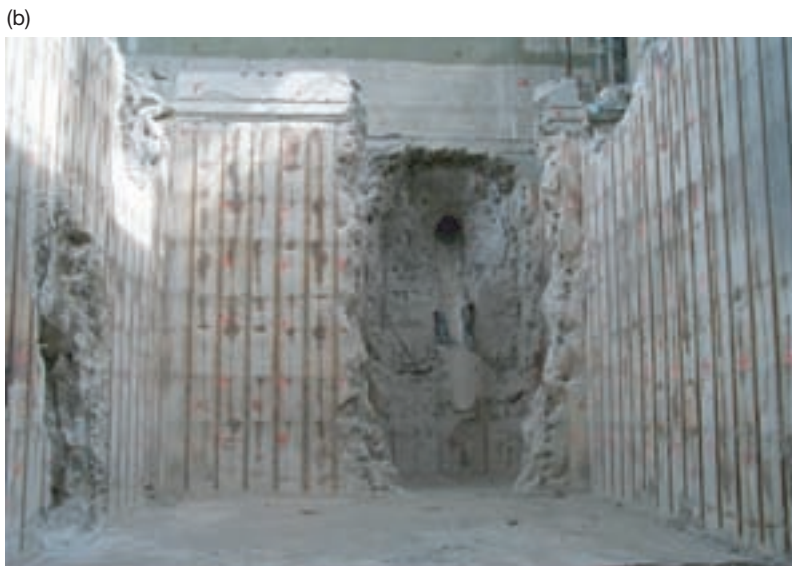
FIG. III-2. An embedded pipe at Vandellós 1 nuclear power plant before (a) and after (b) removal.

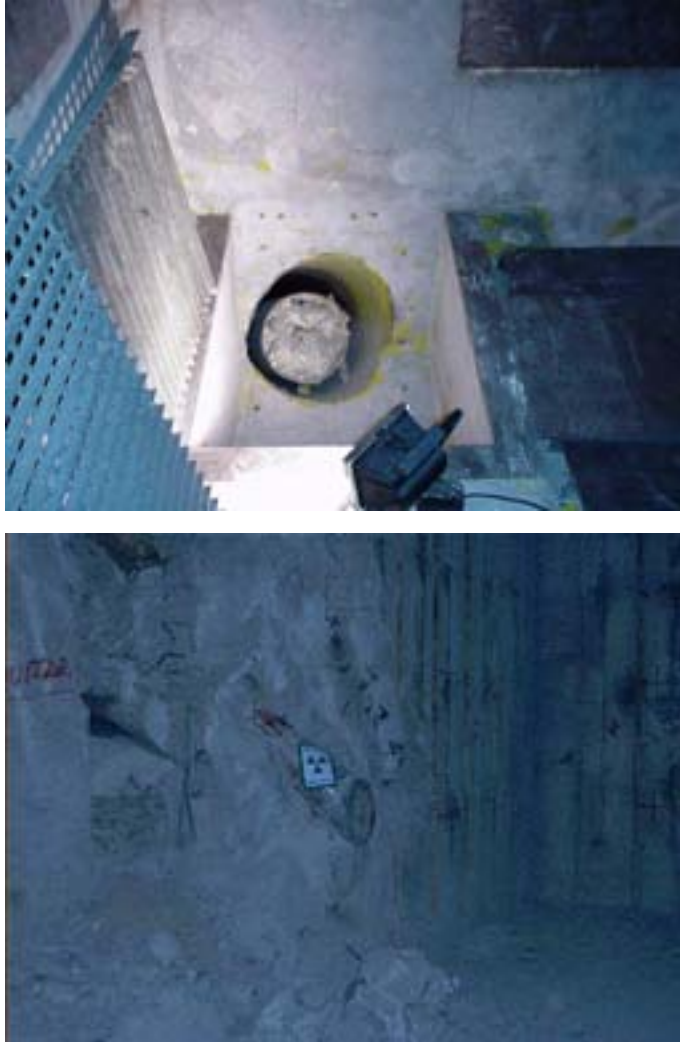
FIG. III-3. The two ends of the embedded pipe at Vandellós 1 nuclear power plant shown in Fig. III-2 (a).

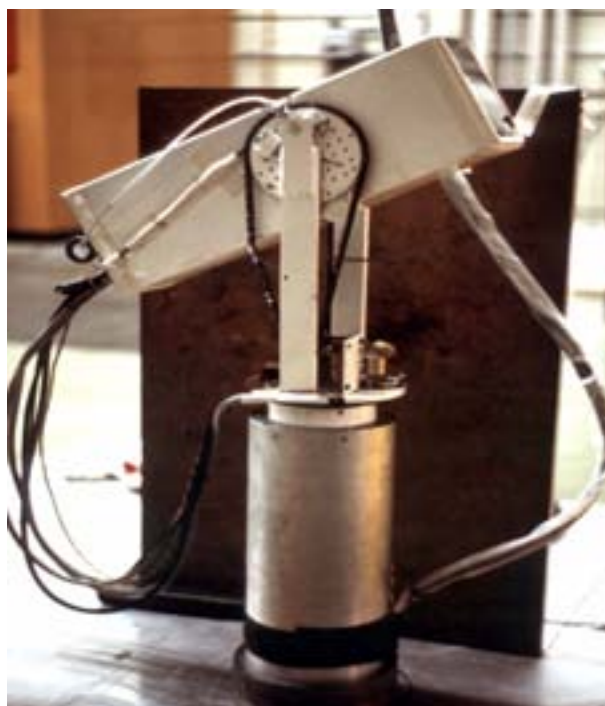
FIG. IV-2. The TV camera with custom made swivel and tilt joints used at Lucens.

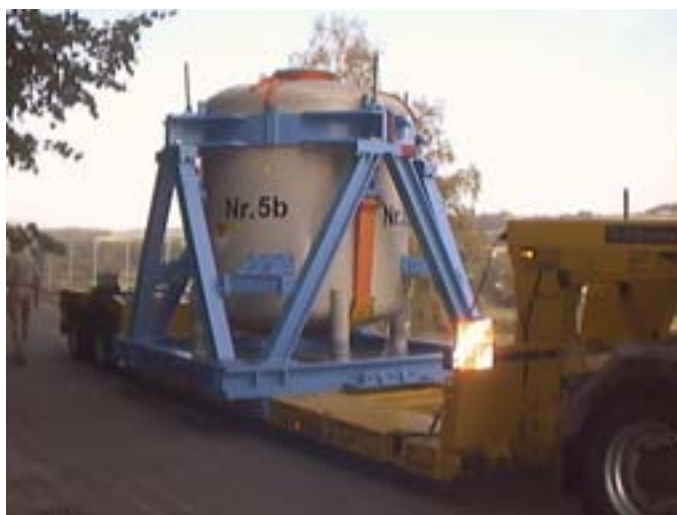
FIG. IV-7. Special containers for transportation of large components from the former research reactor at Lucens to the Swiss central interim storage facility (ZWILAG).

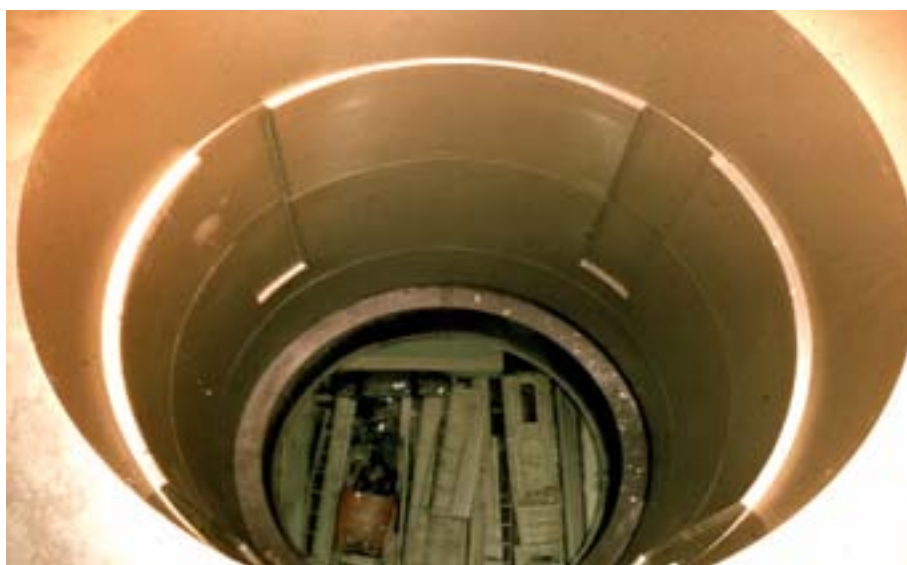
FIG. IV-8. The emptied and cleaned-up reactor pit at Lucens.

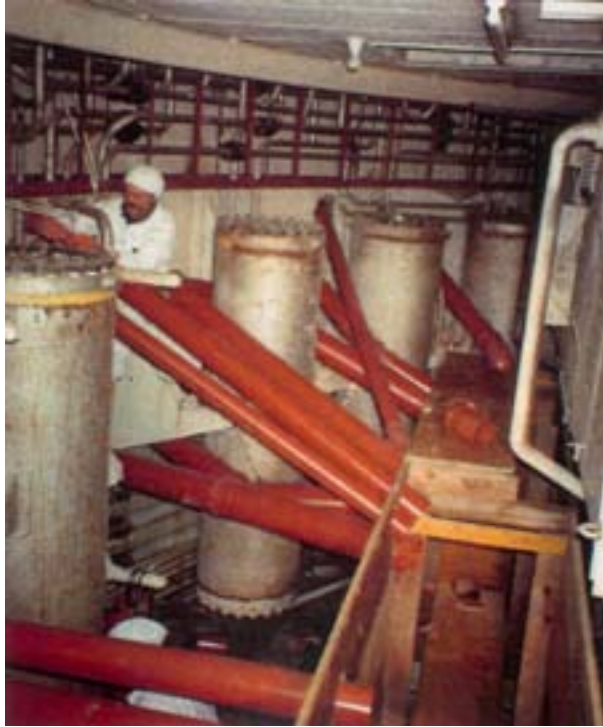
FIG. IV-9. Installation of a new cavern drainage system at Lucens.

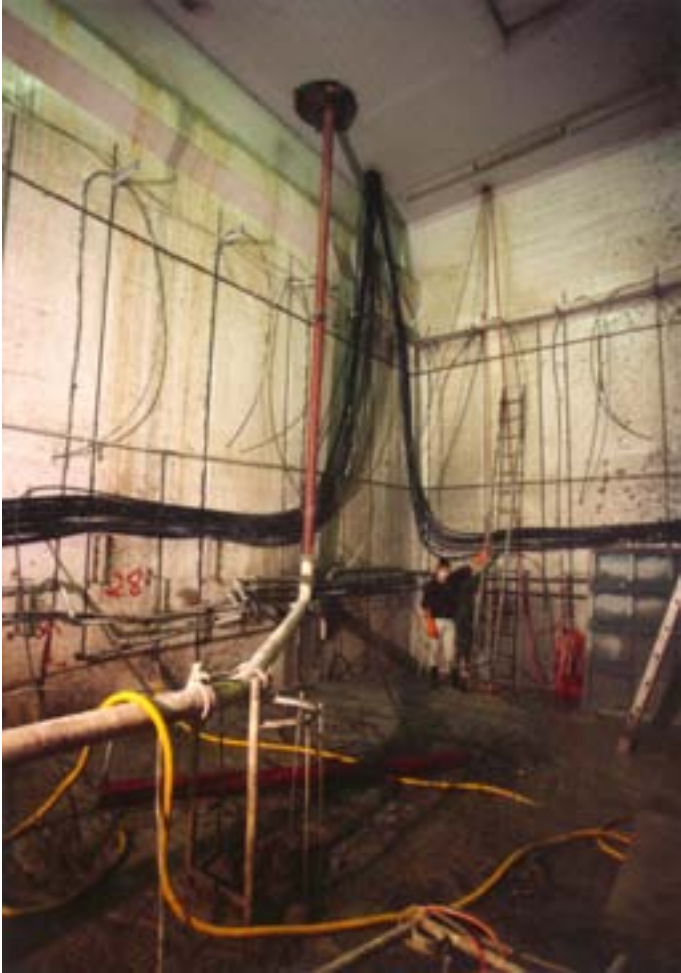
FIG. IV-10. Installation of a grouting hose system at Lucens.

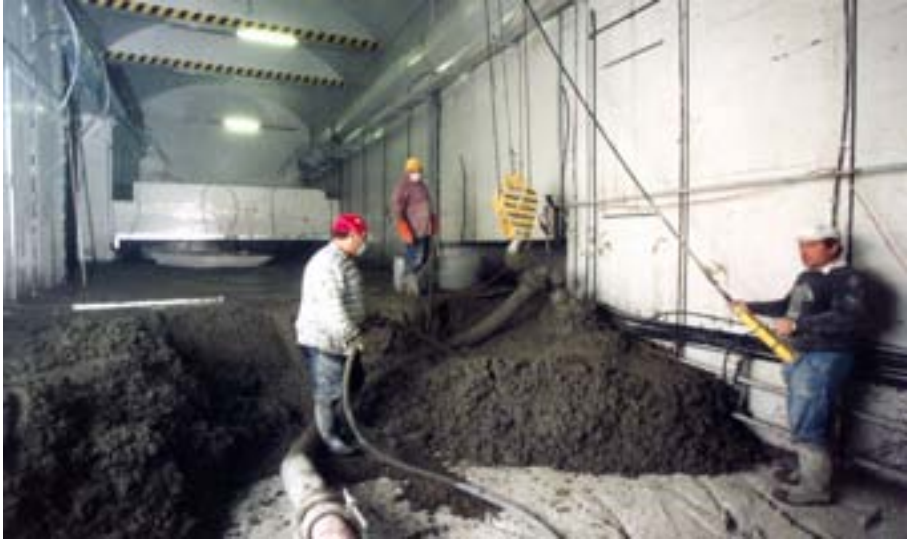
FIG. IV-11. Refilling of caverns with concrete at Lucens.

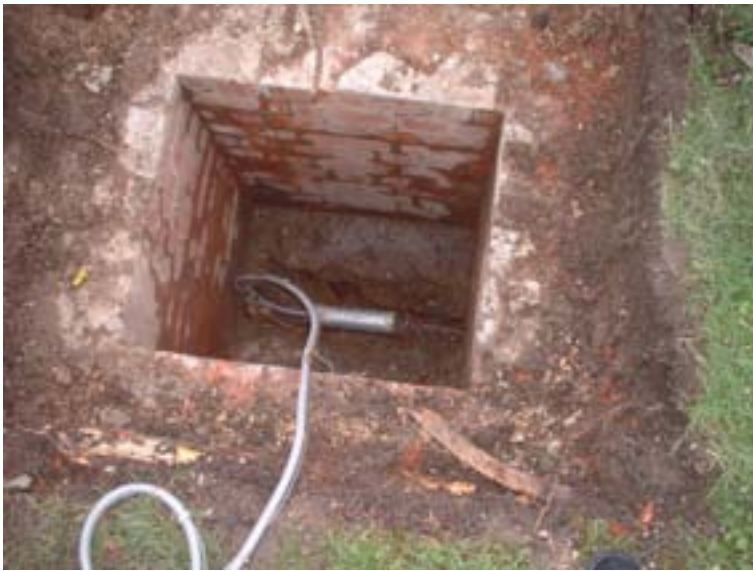
FIG. V-2. The pipe survey equipment in use at Harwell, UK.

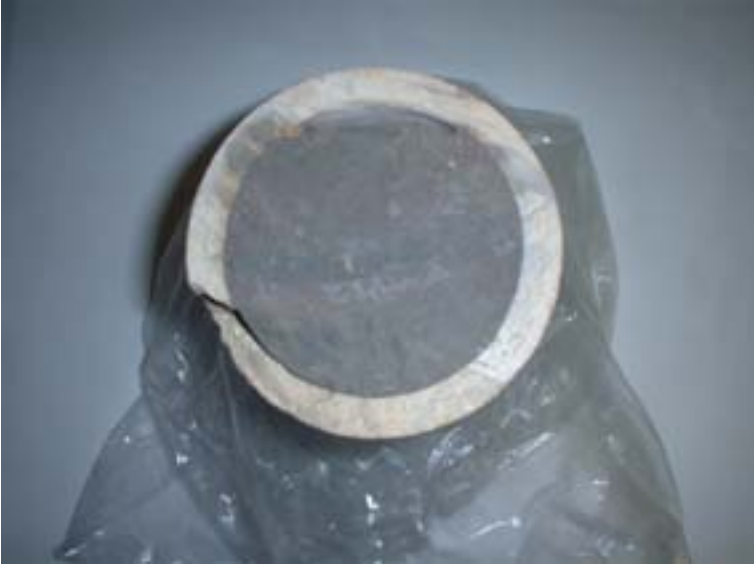
FIG. V-3. Grouted drain section at Harwell, UK.

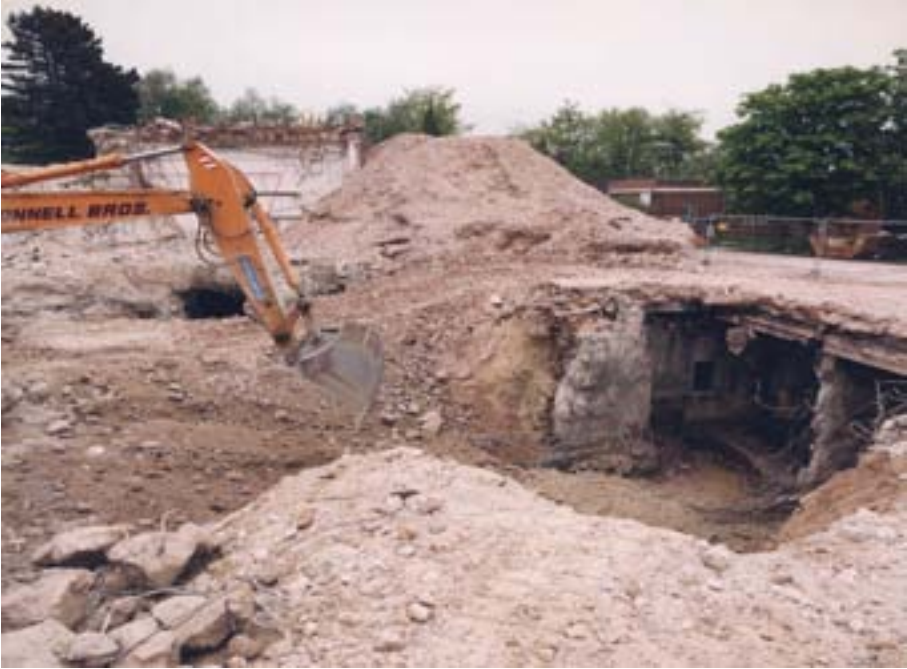
FIG. V-4. Demolition of the BEPO outlet duct at Harwell, UK.

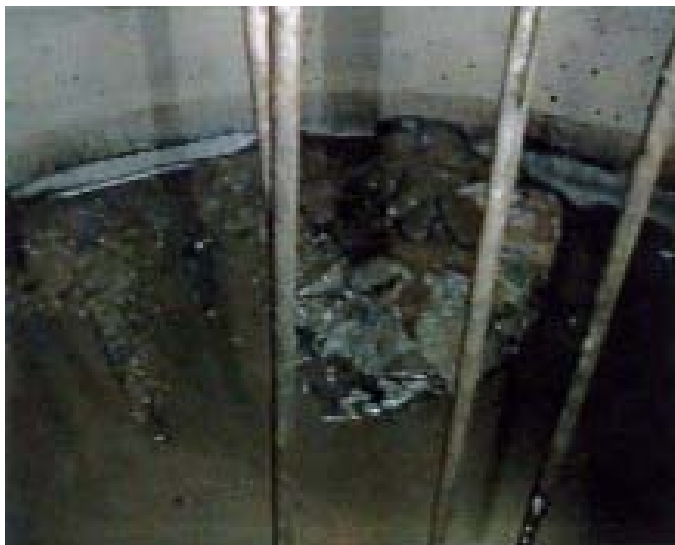
FIG. VII-2. Example of the situation at the bottom of tanks at the A-1 nuclear power plant at Jaslovské Bohunice.

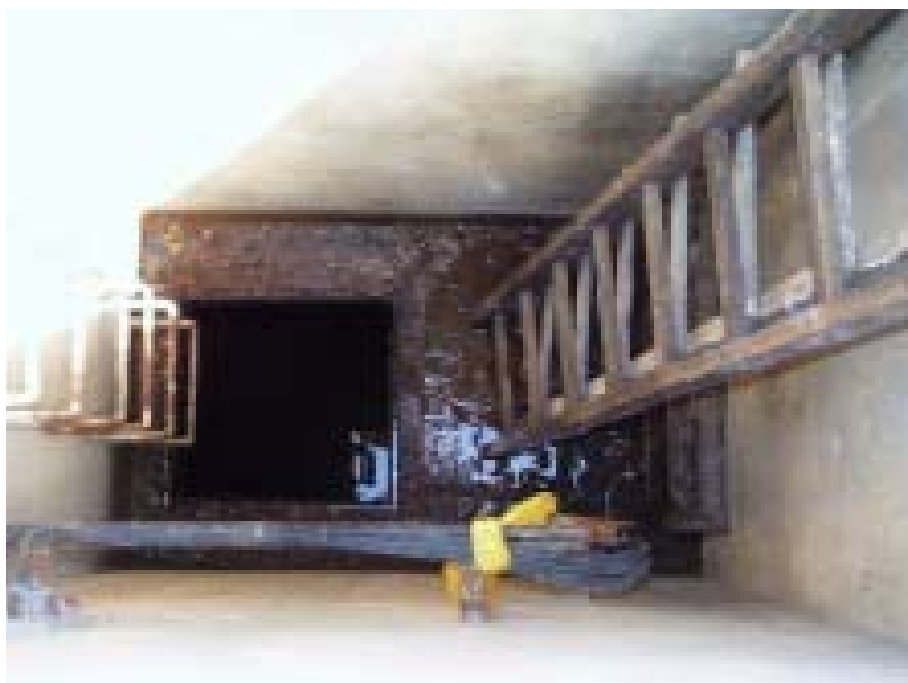
FIG. VII-3. Example of the situation in an inspection shaft at the A-1 nuclear power plant at Jaslovské Bohunice.

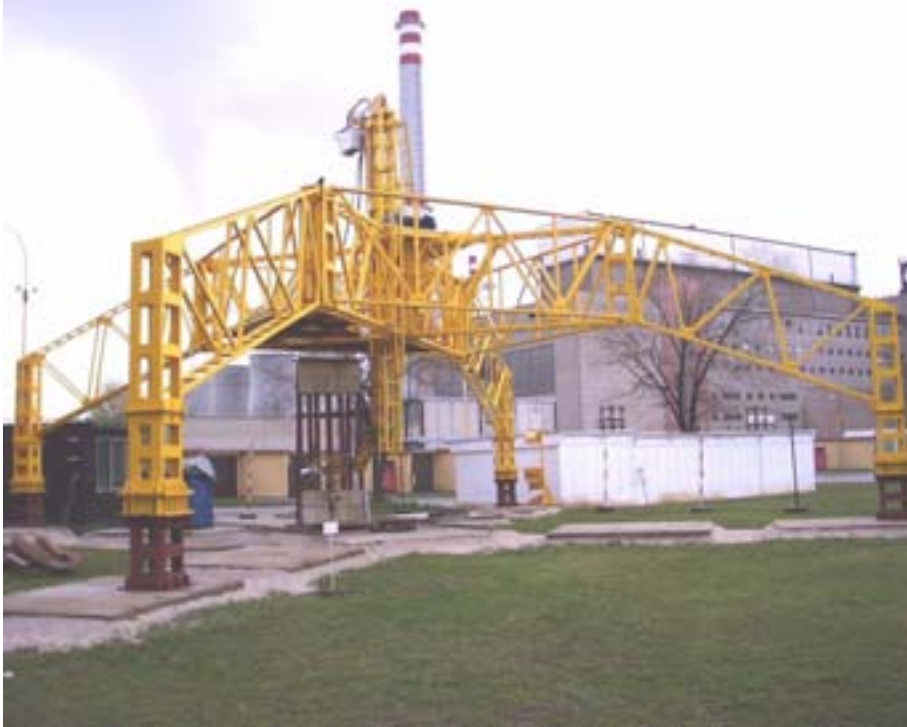
FIG. VII-4. The DENAR-41 manipulator.

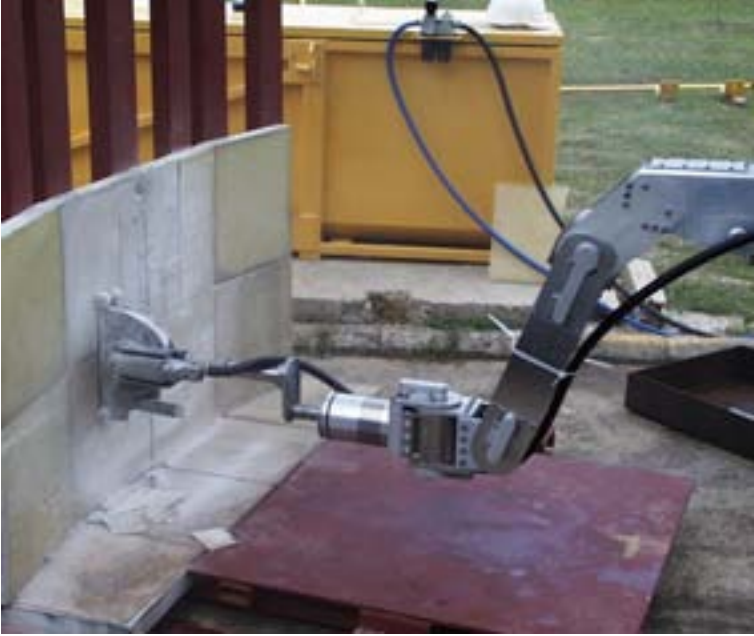
FIG. VII-5. Mock-up testing of the cutting of underground tanks at the A-1 nuclear power plant at Jaslovské Bohunice.

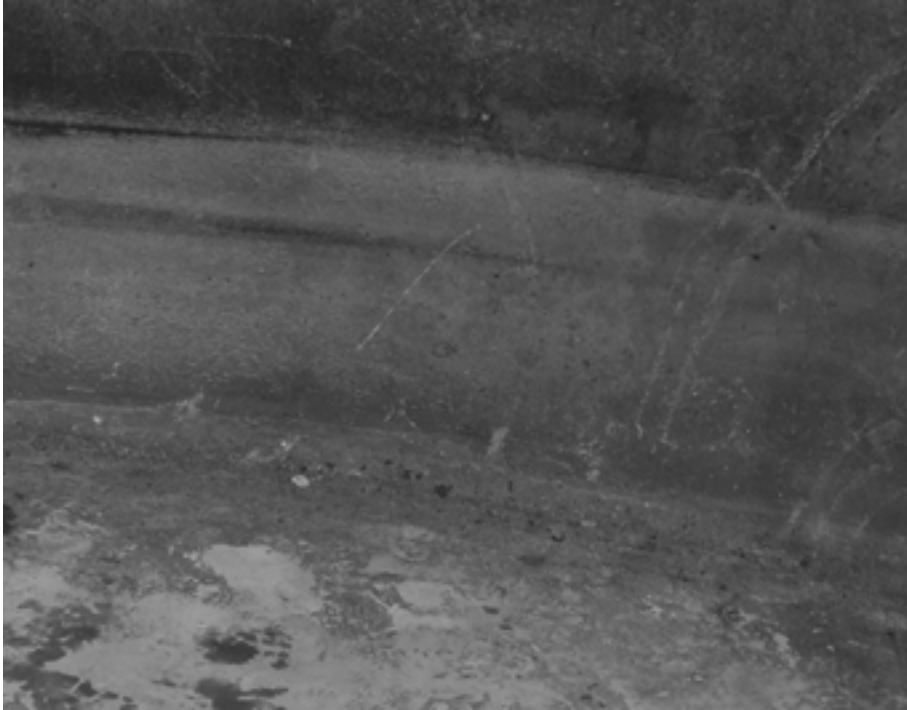
FIG. VII-7. Example of the state after decontamination of the surface of an underground tank at the A-1 nuclear power plant at Jaslovské Bohunice.

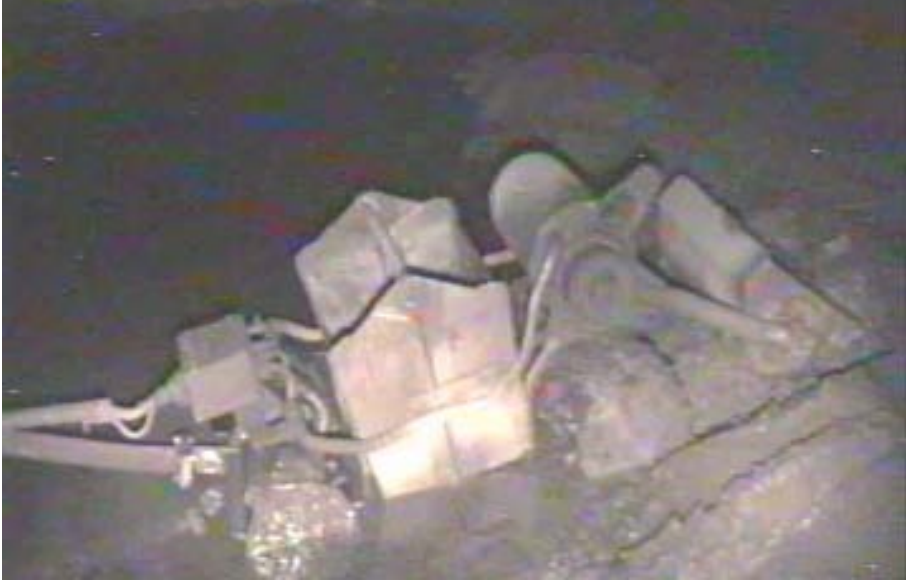
FIG. VII-9. A so-called 'sludge walker' at the A-1 nuclear power plant at Jaslovské Bohunice.
