TECHNICAL REPORTS SERIES NO. 439

Decommissioning of Underground Structures, Systems and Components

INTERNATIONAL ATOMIC ENERGY AGENCY
VIENNA, 2006

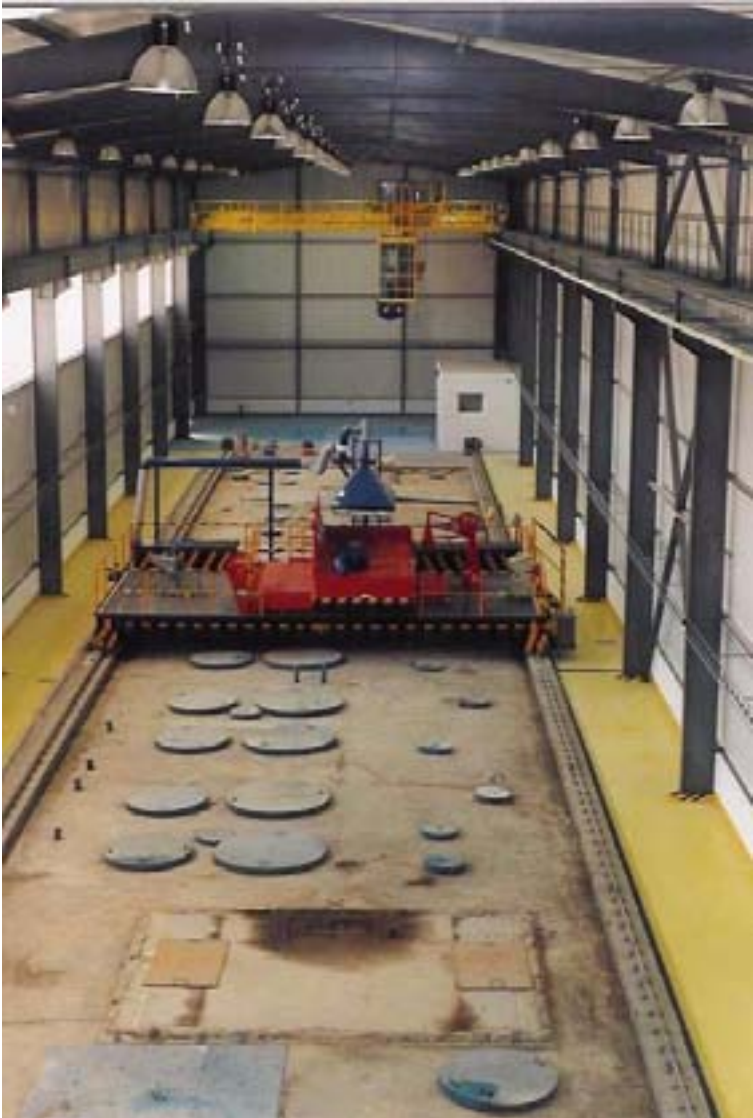
FIG. VII-10. The solid radioactive waste storage facility at the A-1 nuclear power plant at Jaslovské Bohunice.

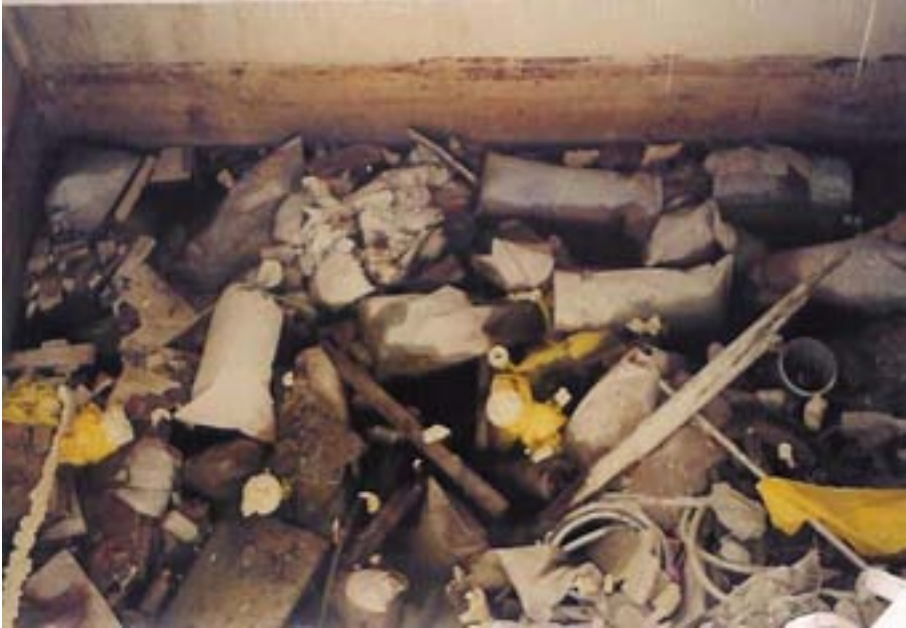
FIG. VII-11. Example of the wastes inside the SRWSF tanks at the A-1 nuclear power plant at Jaslovské Bohunice.

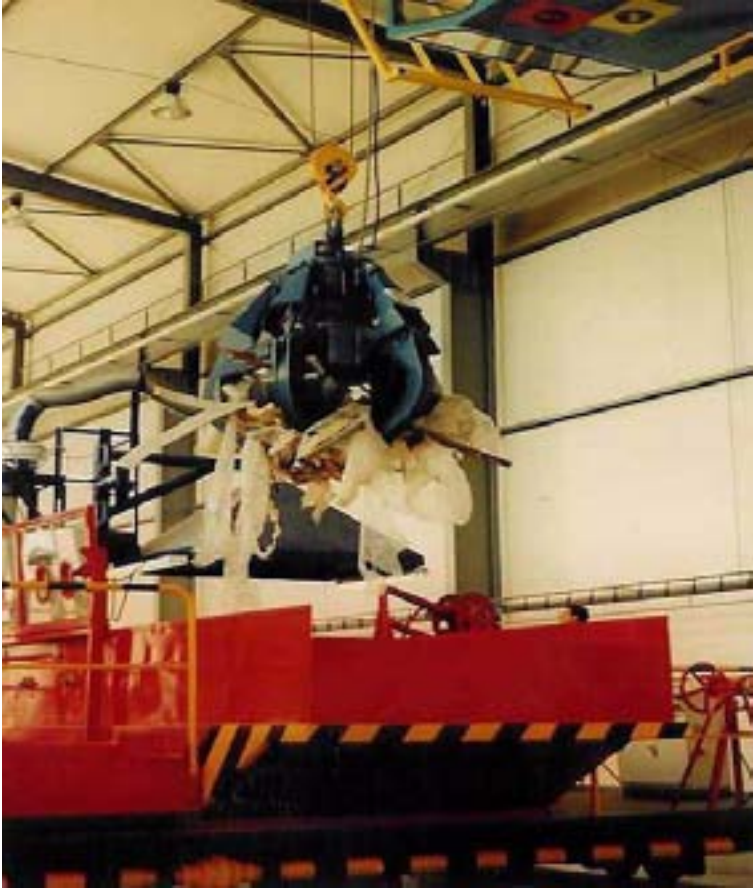
FIG. VII-12. Retrieval of solid wastes from the SRWSF tanks at the A-1 nuclear power plant at Jaslovské Bohunice.

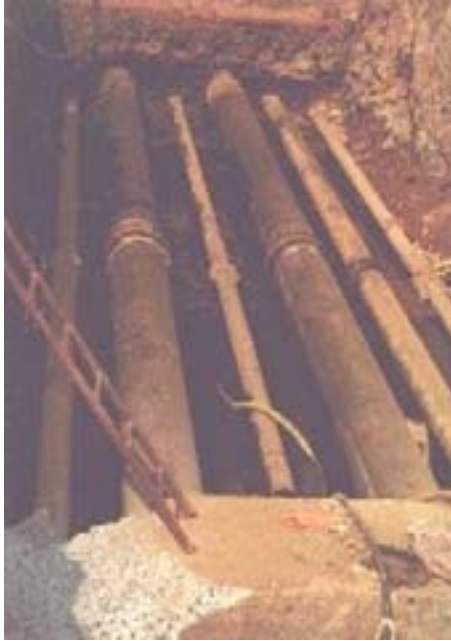
FIG. VIII-1. View of underground pipes at the Cirus reactor, India.

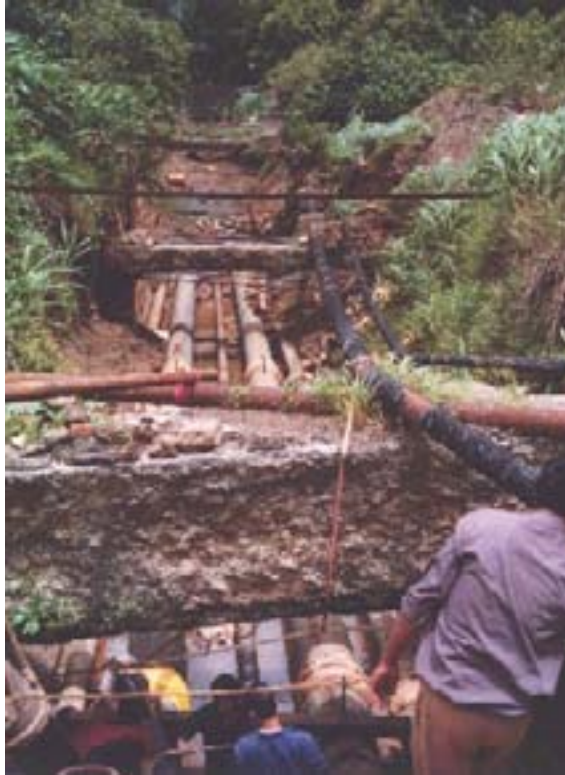
FIG. VIII-3. View of the underground pipes near completion of work at the Cirus reactor, India.

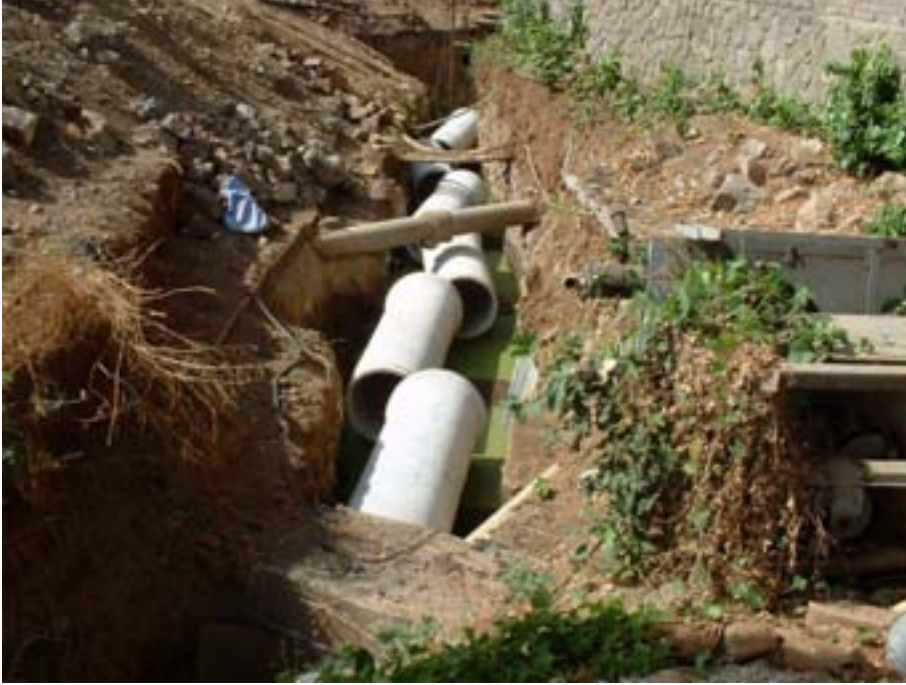
FIG. VIII-4. New underground ventilation concrete pipes being laid after removal of the old pipes at the Cirus reactor, India.

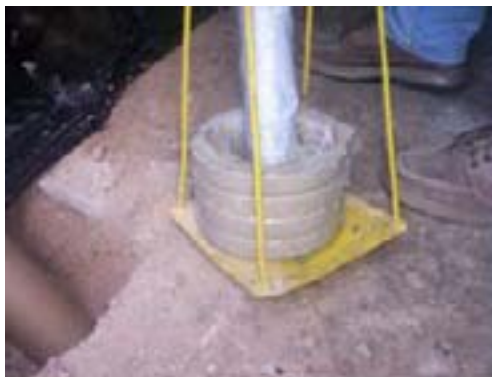
FIG. IX-2. Dose rate monitoring on a floor surface at INOR, Havana.

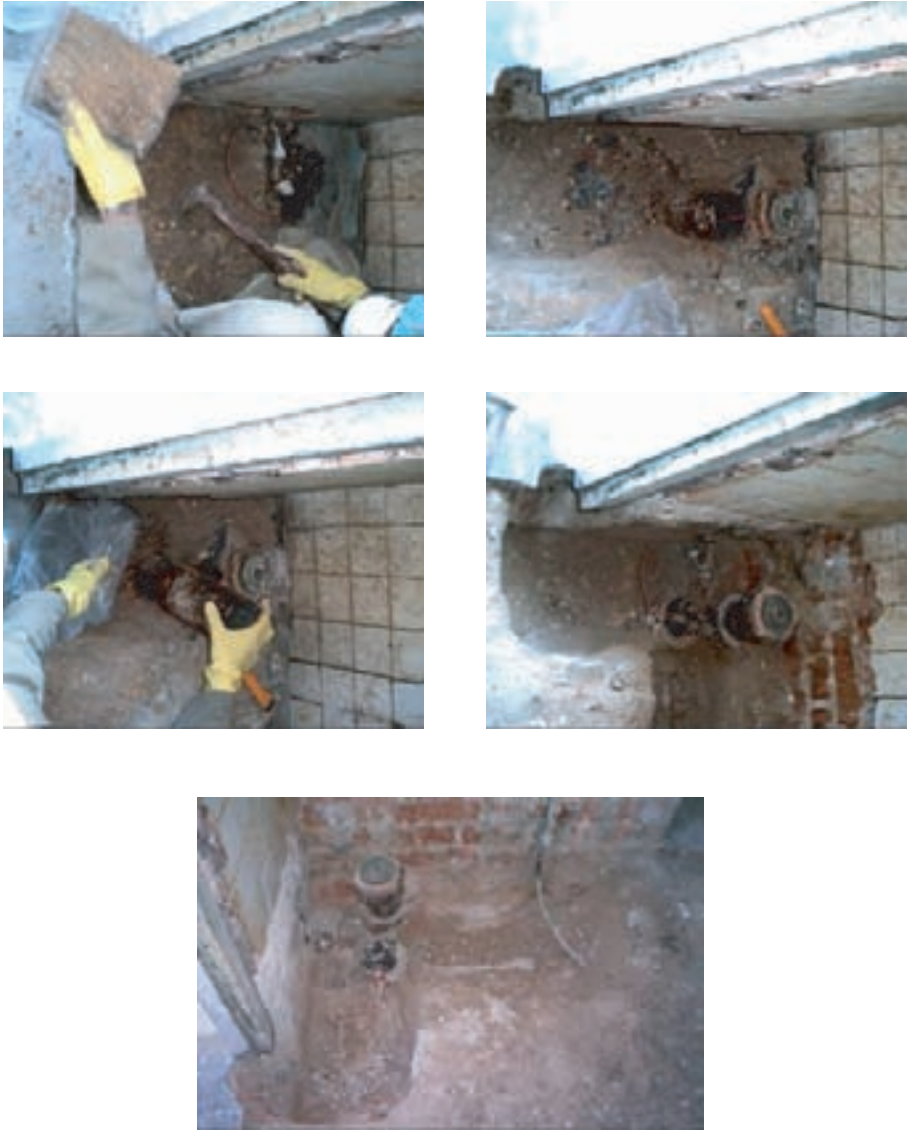
FIG. IX-5. Removal of traps and surrounding material at INOR, Havana.

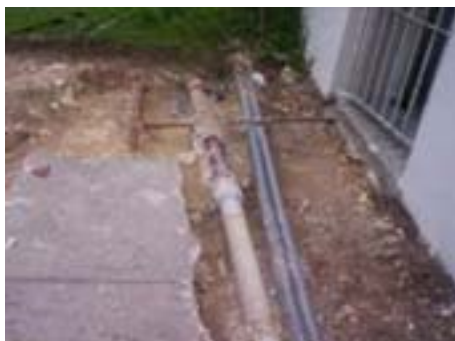
FIG. IX-8. Pipe found in the garden at INOR, Havana.

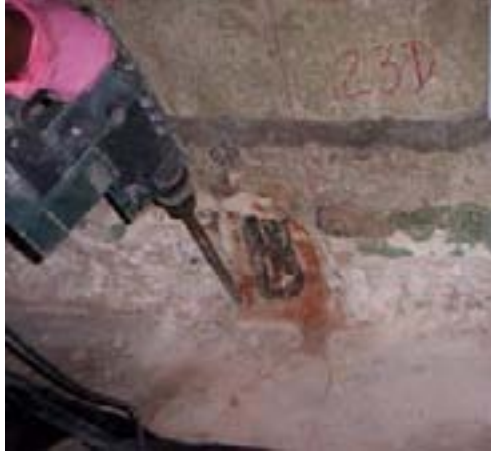
FIG. IX-9. Pipe embedded in a wall at INOR, Havana.

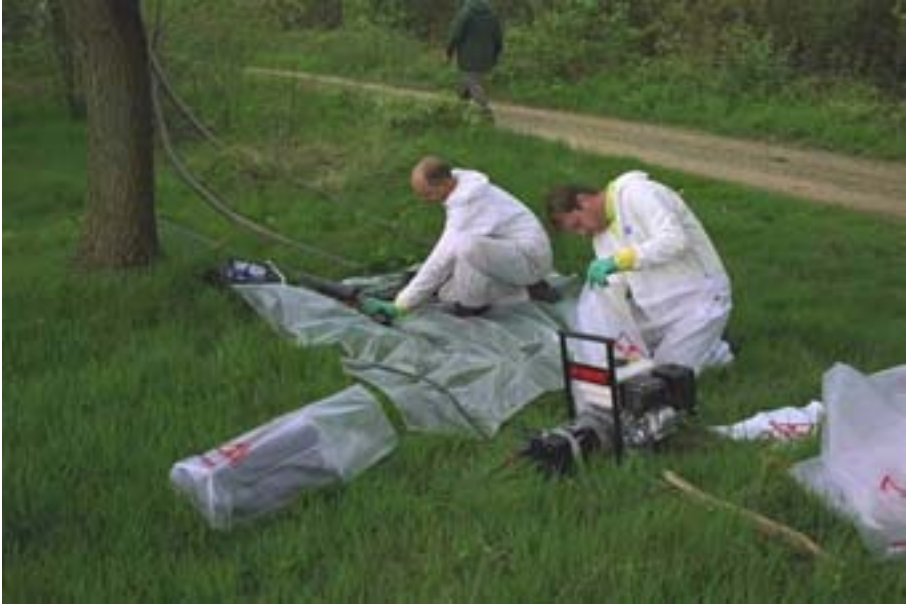
FIG. X-2. The segments are cut on-site and placed in plastic bags, Molse Nete, Belgium.
